REPORT ON THE STATE OF THE ART

Mitigation of Flood and Erosion Damage to Residential Buildings in Coastal Areas

Federal Emergency Management Agency
Mitigation Directorate
Federal Insurance Administration

October 1994

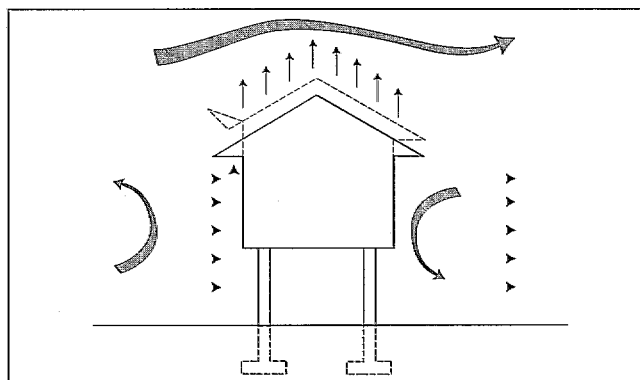
Horizontal wind forces and associated suction (negative forces) on the rear wall can cause an overturning effect.

As the wind blows over the roof, its increasing speed can draw the roof upward and off the house. Wind forces also stress connections between structural members, such as between piles and floor beams, weakening the structure.

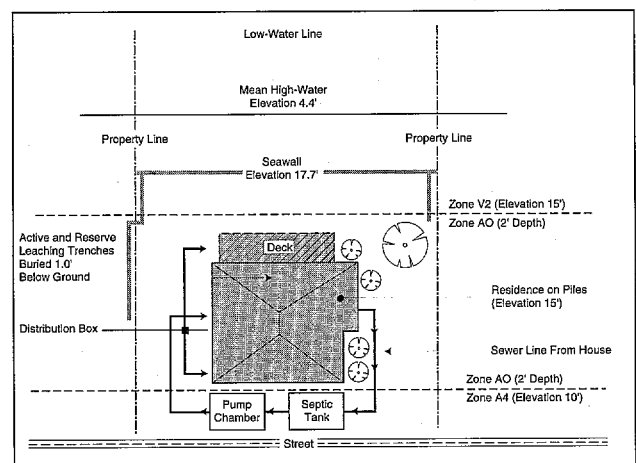
- Residential structure on Atlantic Ocean elevated on wood piles. Seawall of 17.7 feet above sea level protects the home from direct wave action. Owner chose to elevate for added safety.
- Property located in three separate flood insurance zones: Zone V with BFE of 15 feet; Zone A with BFE of 10 feet; and Zone AO with depth of 2 feet.

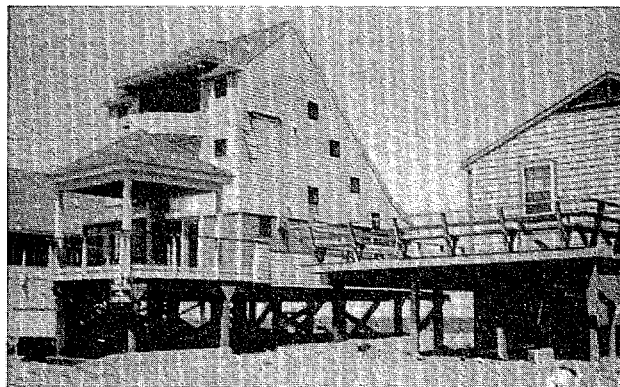
- State environmental codes prohibit placement of septic systems in Zones V and AO.
- Septic system was placed in the small portion of an A Zone located at the property's landward end.

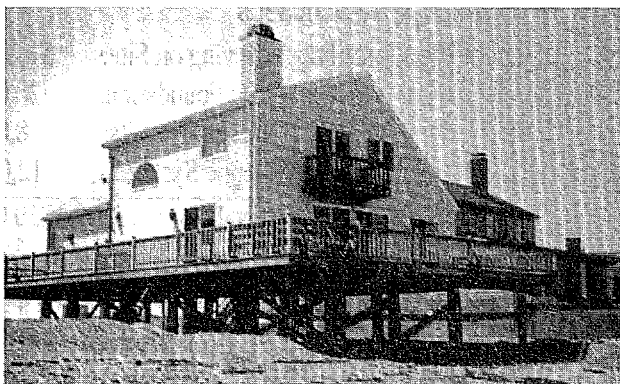
Decking is generally supported by concrete columns. Additional piles or a deeper foundation are used when disturbed soil is encountered.

Flexible connections between building support beams and wooden piles allow adjustments to be made to account for imperfect pile driving.

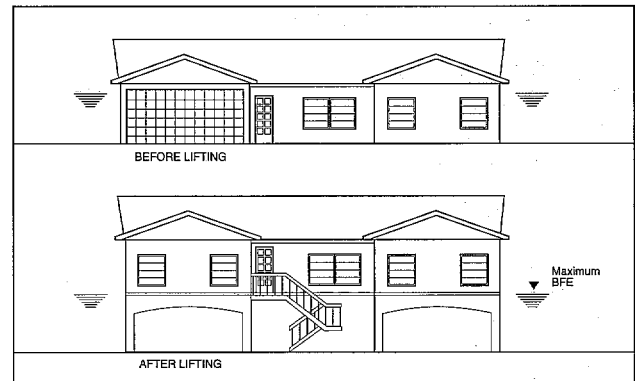
This patented lifting method of elevation involves placing steel lifting beams on top of the floor and pulling it up by suspender rods. The main beams extend through openings in the wall to lifting posts around the house.
